LPC# 0971900001 Lake County  
Waukegan Muni #1 Landfill - Waukegan  
ILD 980902175  
SF/HRS

# Site Reassessment

**WAUKEGAN MUNICIPAL #1 LANDFILL  
WAUKEGAN, ILLINOIS**

**December 19, 2018**

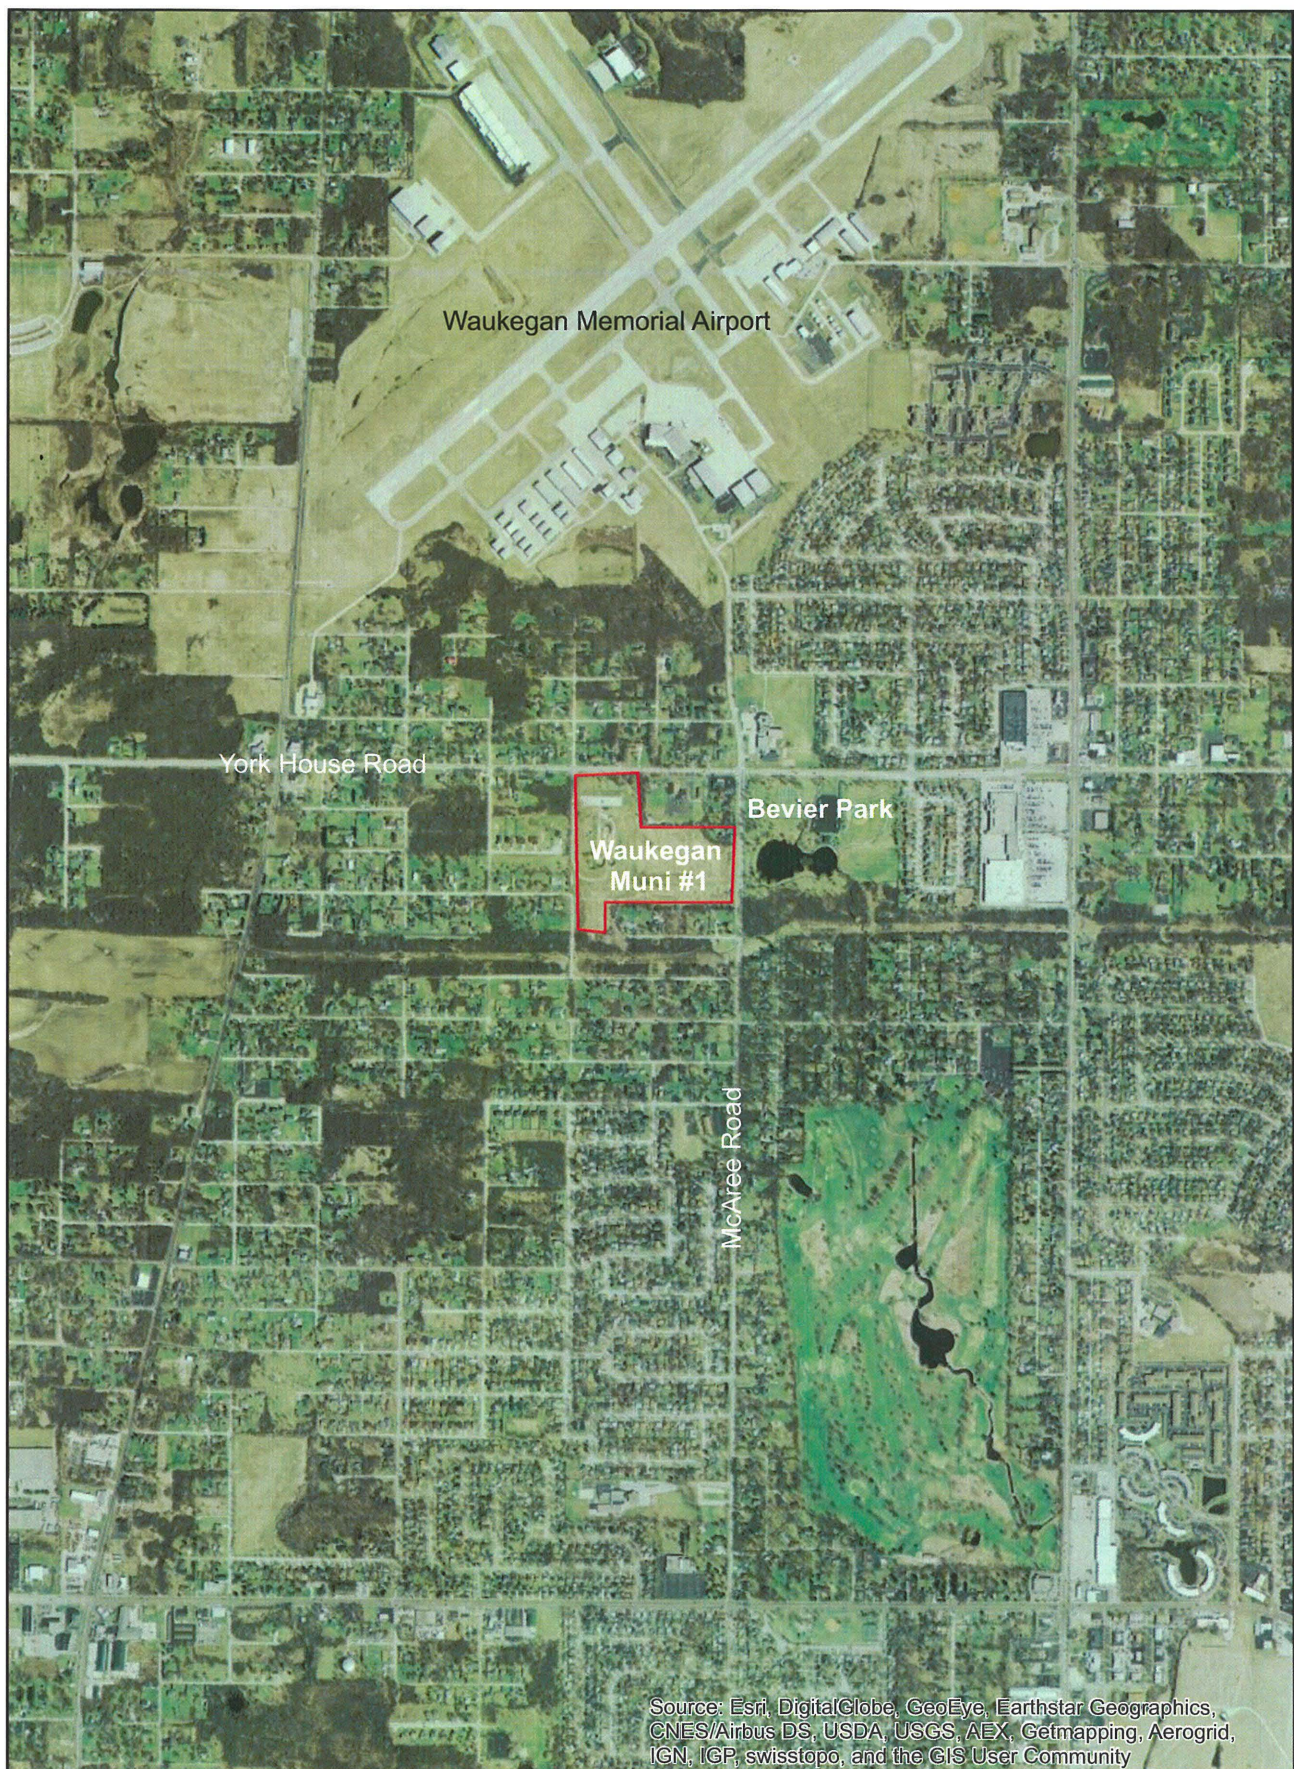
Figure 3

Surface water drainage from the former landfill flows east into Bevier Park, ending in the Bevier Park pond, approximately 190 feet east of the landfills eastern property boundary and is noted as the nearest body of water to the site and also designated as the Probable Point of Entry (PPE) to surface water from the site. According to the Illinois Department of Natural Resources (IDNR) the pond is indicated as a fishery with regulations designating catch limits for all fish species present. The pond appears to be the head waters of Yeoman Creek, which, according to the U.S. Geological Survey (USGS) 7.5 minute Zion Quadrangle map and the National Wetlands Inventory Maps, is an intermittent stream flowing south and southeast approximately 4.5 miles where it joins the Waukegan River which flows 0.6 miles subsequently entering Lake Michigan. The National Wetlands Inventory Map also indicates that Bevier Pond is the closest off-site wetland area (palustrine, unconsolidated bottom, intermittently exposed, excavated) to the landfill. Additional wetlands exist in the drainage ditches surrounding the landfill, the largest area being an approximately two-acre marsh area located at the southwest corner of the landfill.

Waukegan Muni #1 Landfill Site and Surrounding Area

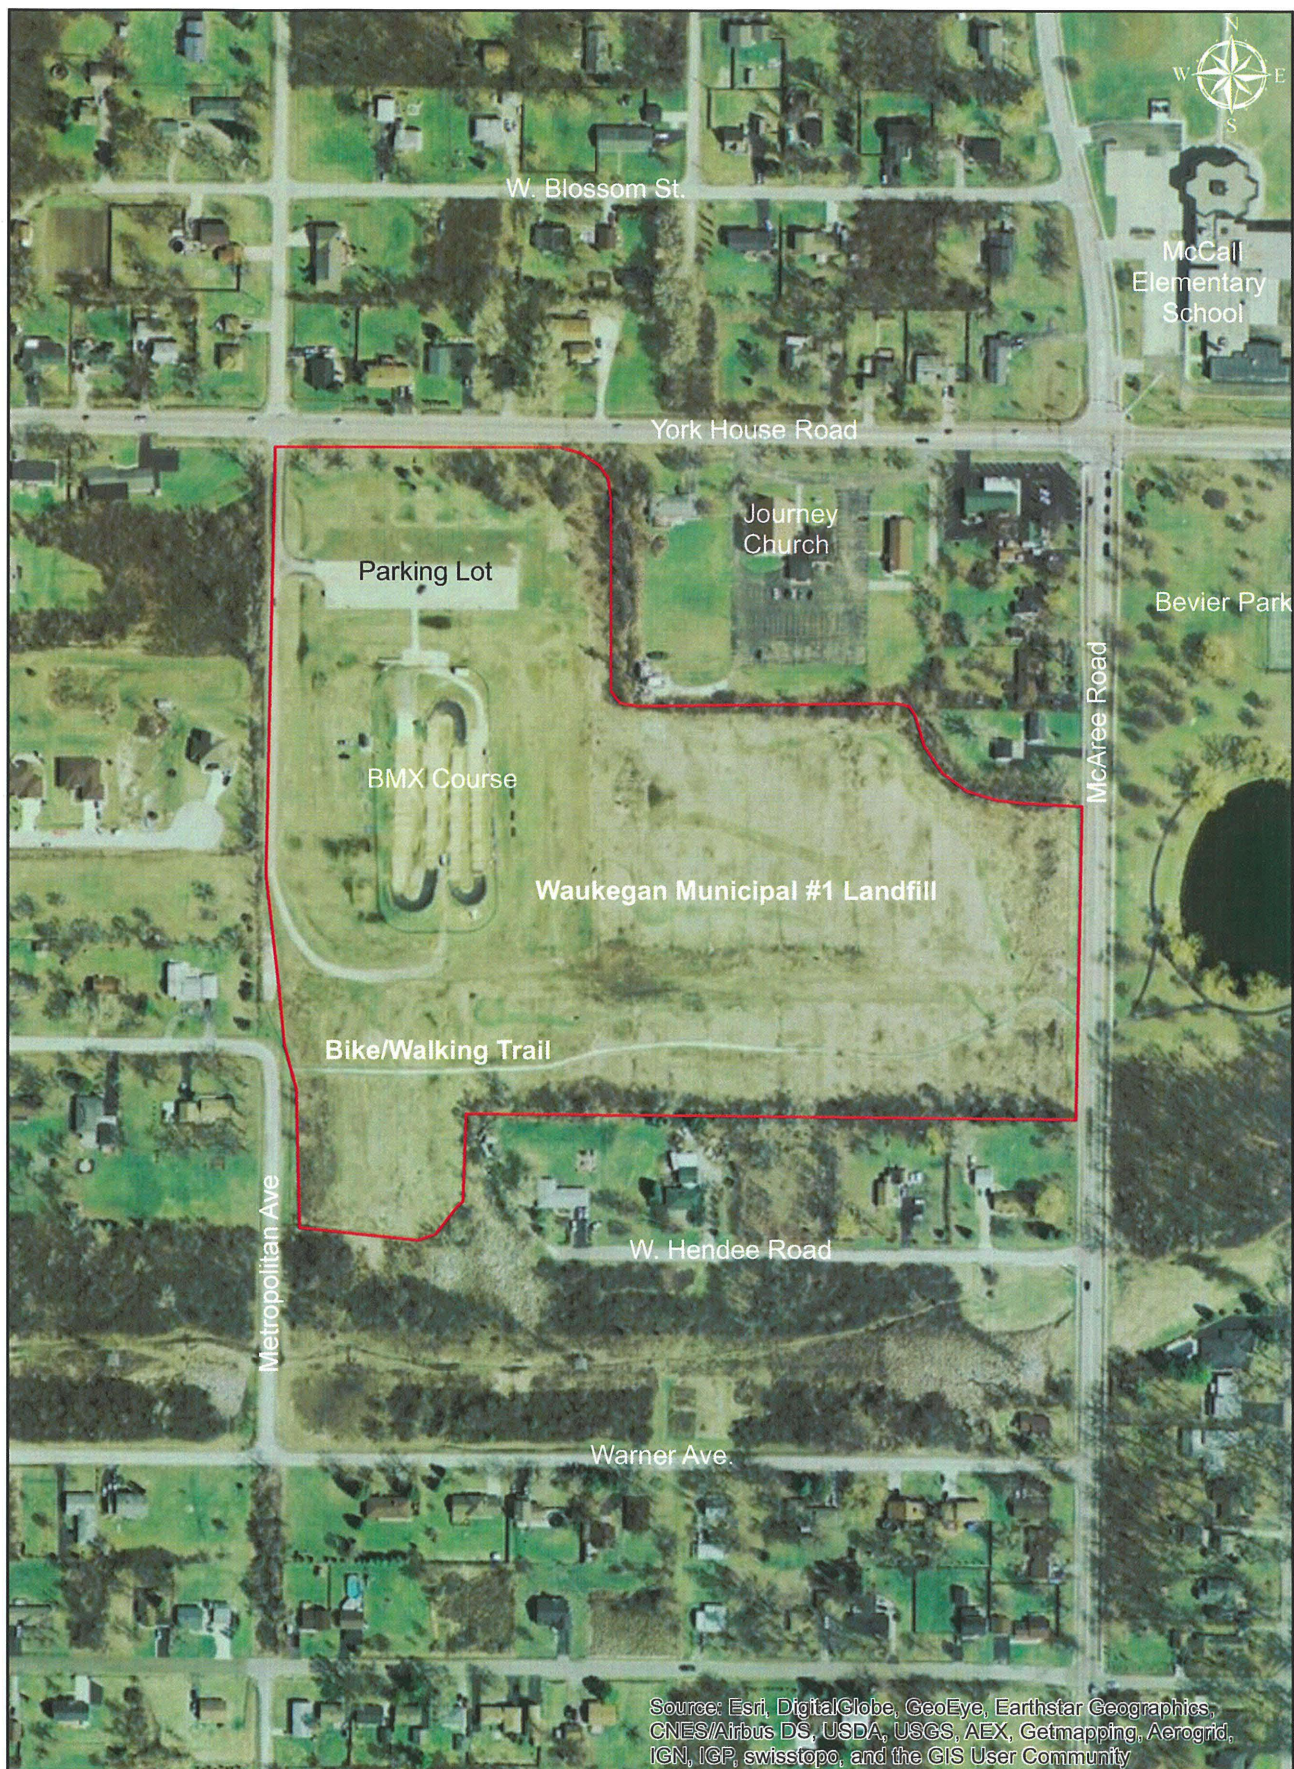
Figure 4

Waukegan Muni #1 Landfill Site Property

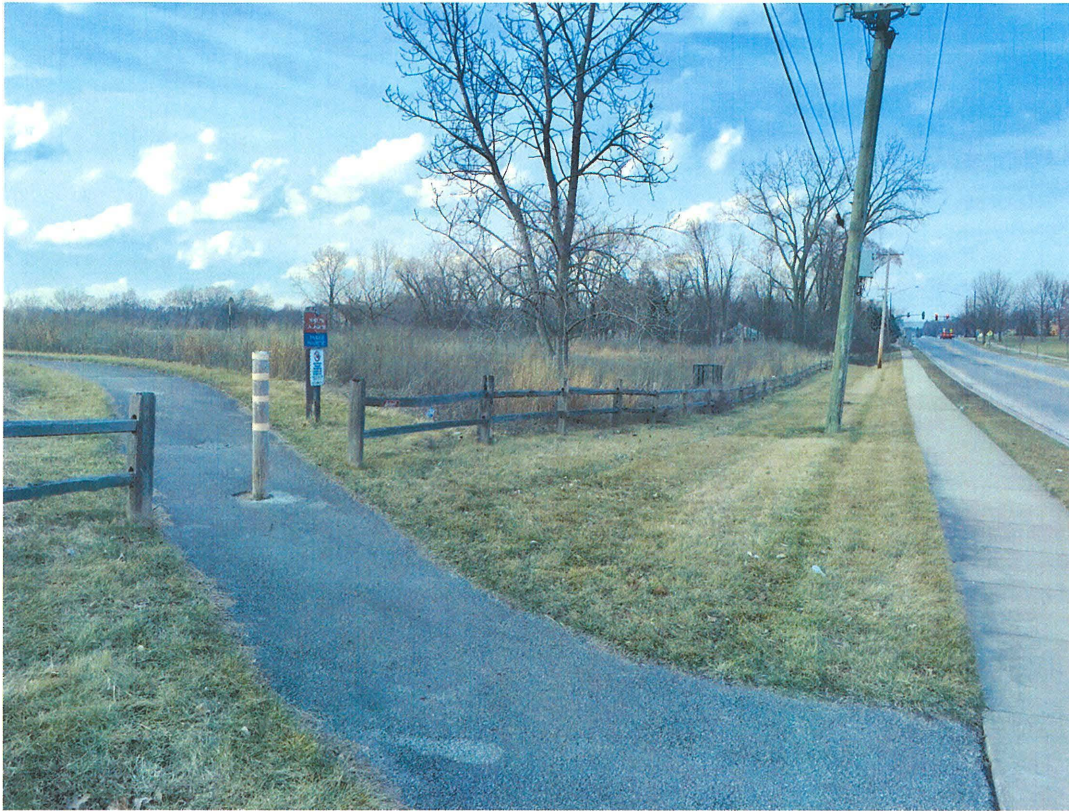
Photo #1

- (Photo #1) East side site entrance – photo taken facing north near G102.
- (Photo #2) Asphalt walking path – photo taken facing SW near G102.
- (Photo #3) Asphalt walking path – photo taken facing east near X203.

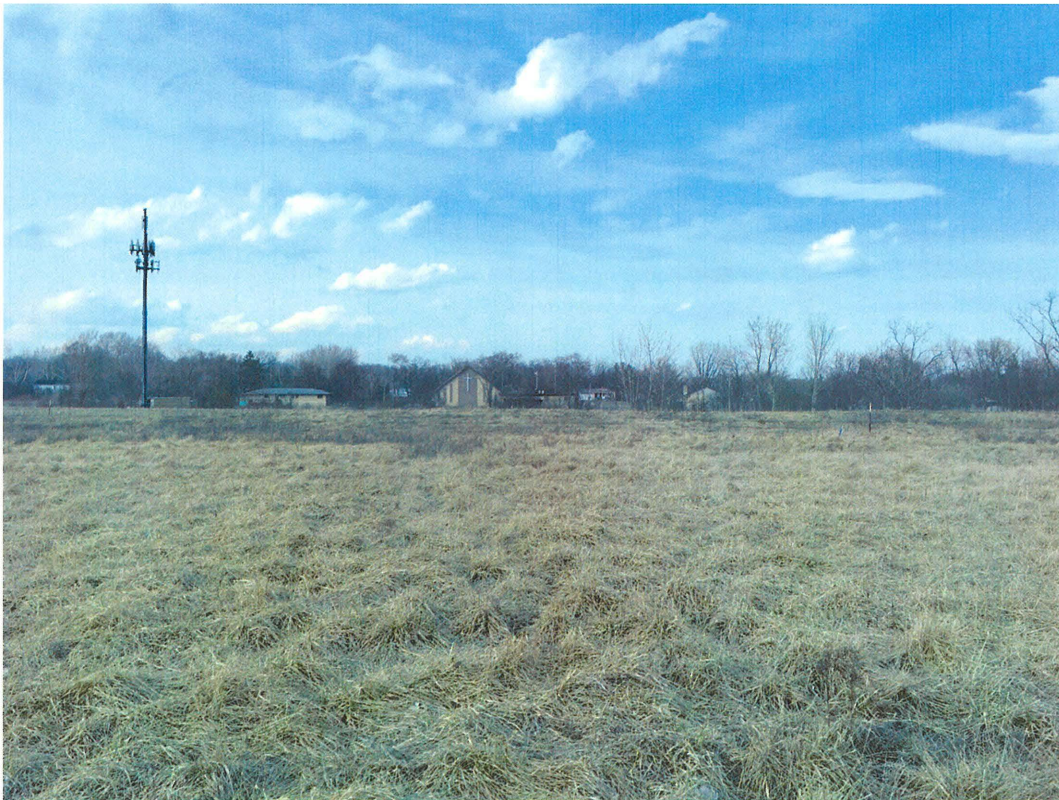
Photo #4

- (Photo #4) Center area of Landfill – photo taken facing north near X203.
- (Photo #5) Gravel walking path – photo taken facing SW near X202.
- Photo #6) West area of landfill, BMX bike track – photo taken facing NW near X202.

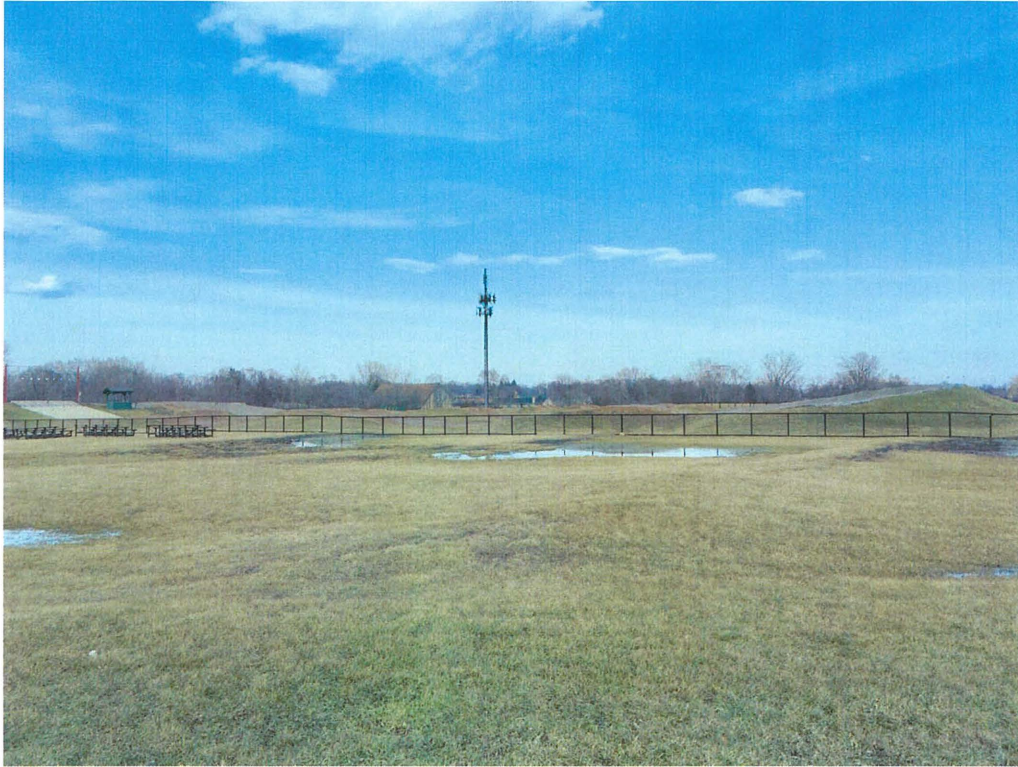
Photo #7

- (Photo #7) West area of landfill, BMX bike track – photo taken facing NE just west of track.
- (Photo #8) West area of landfill, BMX bike track – photo taken facing south at starting gate.

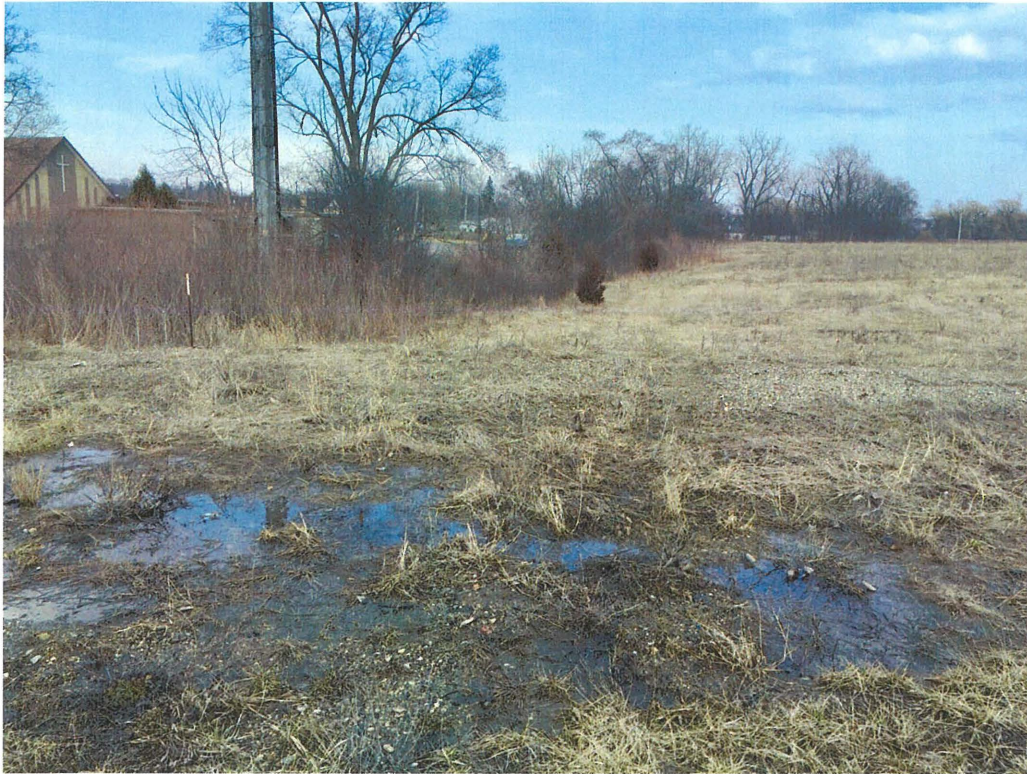
**Photo #9**

- (Photo #9) Near X207 at historical leachate seep area – photo taken facing east. (No active seep).
- (Photo #10) Near X207 at historical leachate seep area – photo taken facing north. (No active seep).

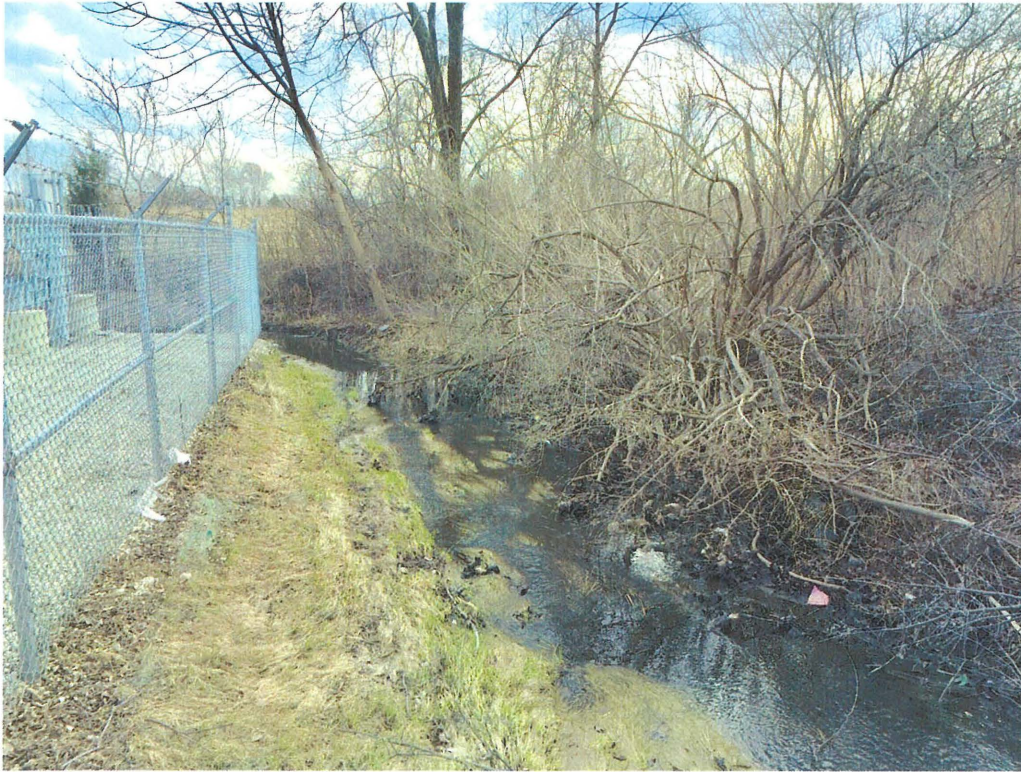
Photo #11

- (Photo #11) Near X207 at historical leachate seep area – photo taken facing south at off site drainage ditch.
- (Photo #12) Near X207 at historical leachate seep area – photo taken facing west at off site drainage ditch.

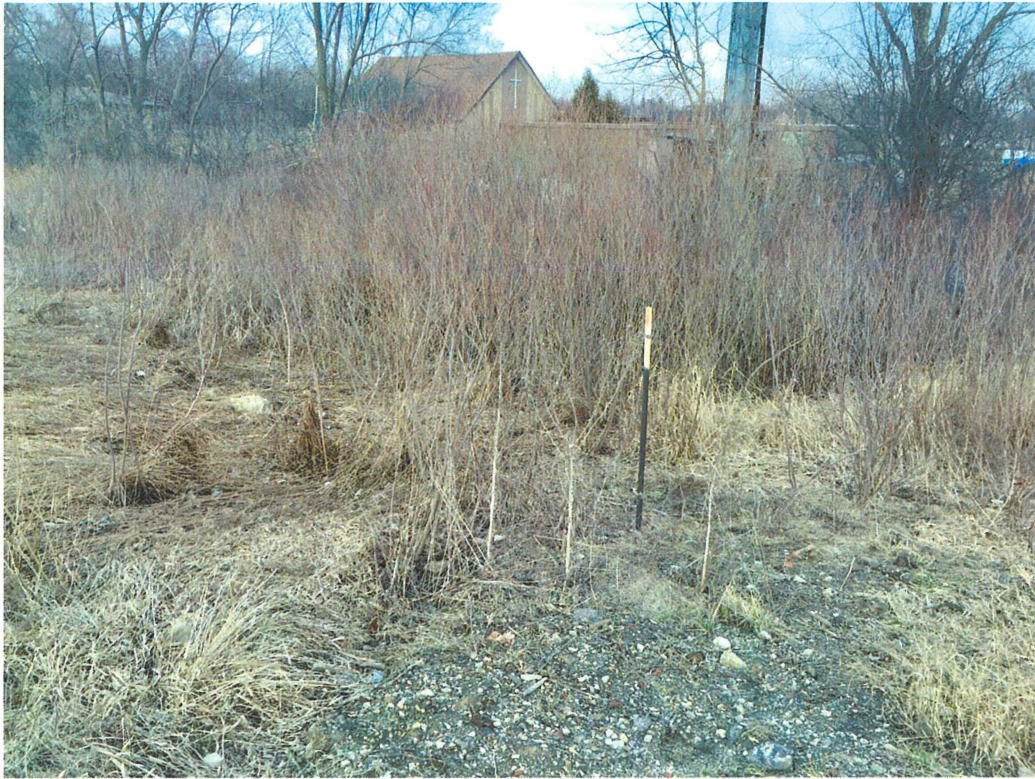
Photo #13

- (Photo #13) Near X207 at historical leachate seep area – photo taken facing NE. (No active seep).
- (Photo #14) Center of landfill area – photo taken facing south between X206 and X207.

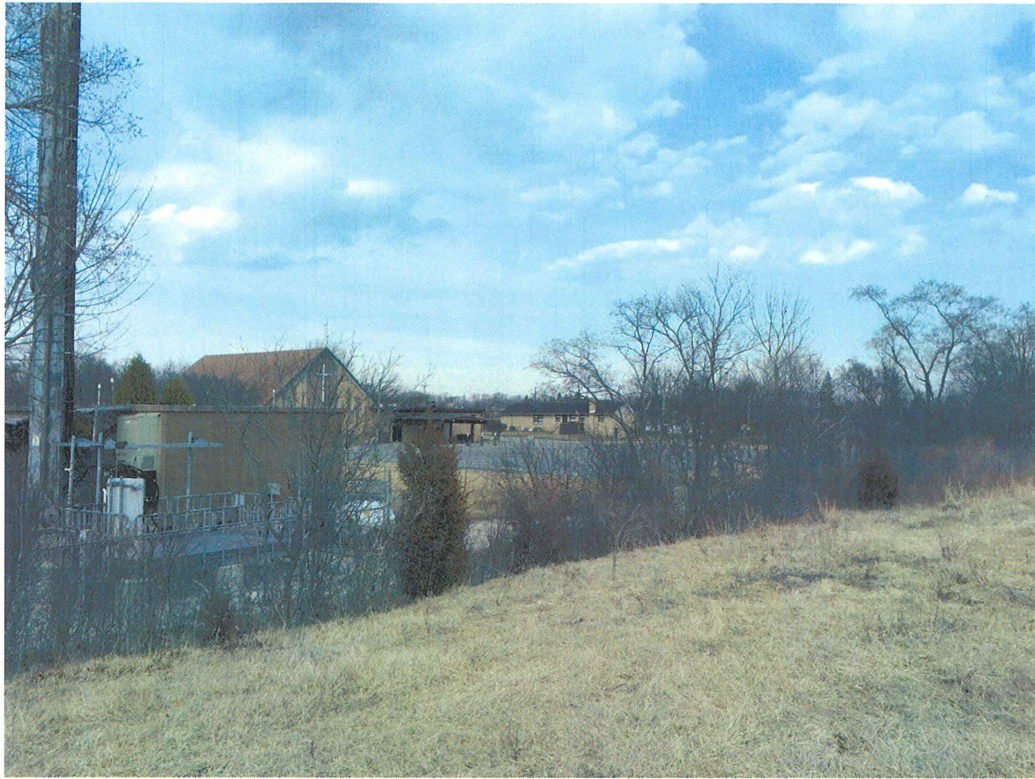
Photo #15

- (Photo #15) Near X207 at historical leachate seep area – photo taken facing NE. (No active seep).
- (Photo #16) West area of landfill – photo taken facing SW between X206 and X207.

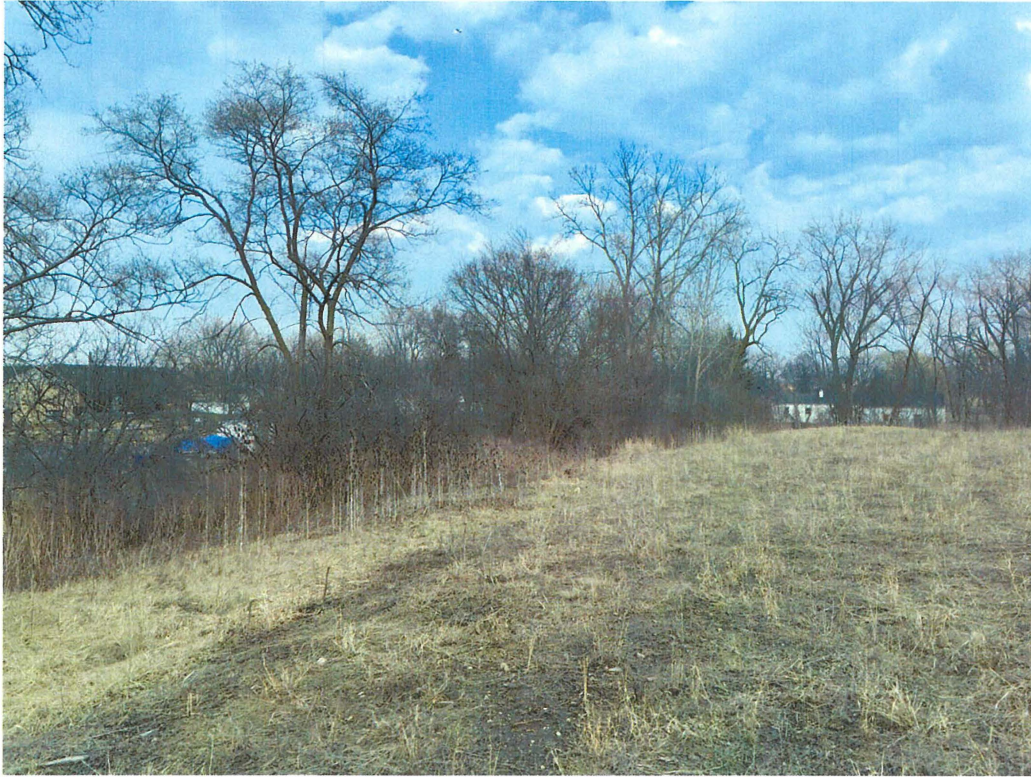
Photo #17

- (Photo #17) North property line of landfill – photo taken facing east between X206 and X207.
- (Photo #18) North side of landfill – photo taken facing north from center area of landfill.

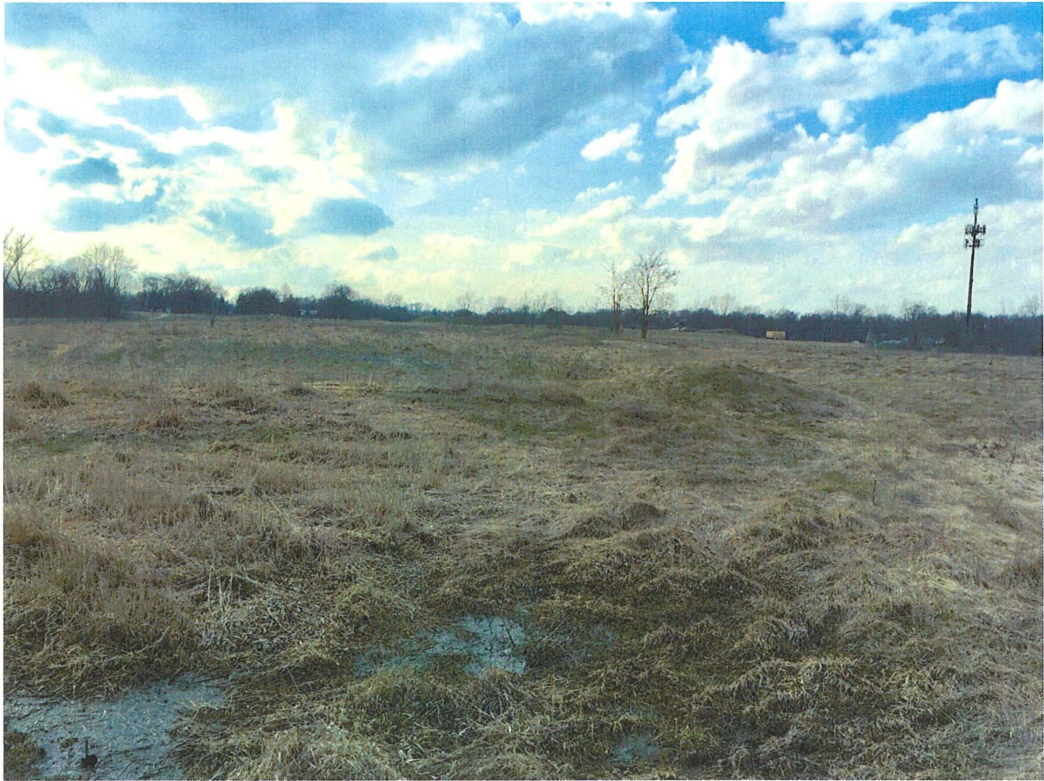
Photo #19

- (Photo #19) West area of landfill – photo taken facing west from center area of landfill.
- (Photo #20) East side of landfill – photo taken facing east from center area of landfill.
